Rehabilitation of the Big Walker Mountain Tunnel in Bristol, Virginia

D. Kukreja, P.E.

P. Moran, P.E. Dr. G. Sauer Corporation, Herndon, Virginia

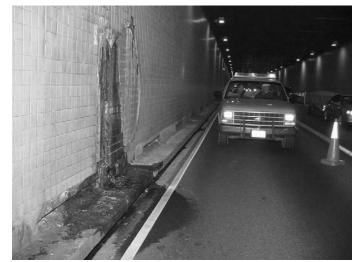
In July 1986, a structural inspection was performed which located and documented numerous cracks in the tunnel lining and expansion joints that were leaking and had caused deterioration to areas of the tunnel lining and finishes. In fact during the winter, the active leaks frequently caused icy conditions near the tunnel portals therefore it was necessary for the tunnel maintenance department to temporarily install heat tape to active leaks to prevent freezing. As a result of leaks that have existed for a period of time, adjacent wall tiles were delaminated (see Figure 4), the roadway pavement had deteriorated and formed potholes, the ceiling slab had dete-

Figure 4. Delaminated tiles.

safety hazard to the public. There was a location above the ceiling slab where the pipe that drained water from the ceiling slab was obviously clogged and created a pond on the slab. This water eventually made its way down the sidewall and resulted in delaminated wall tiles and deteriorated concrete.
