NL: Platform tunnels and cross passages

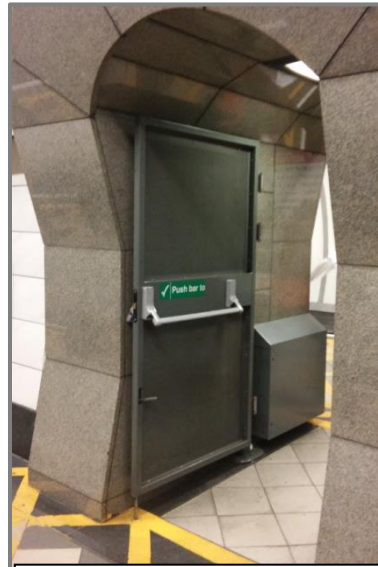
Potential trip hazard ??

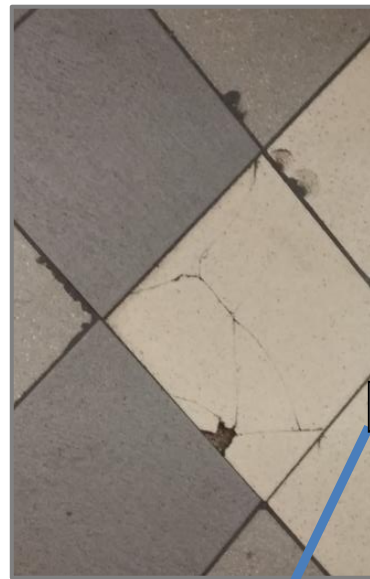
Tiles cracked/broken at the floor

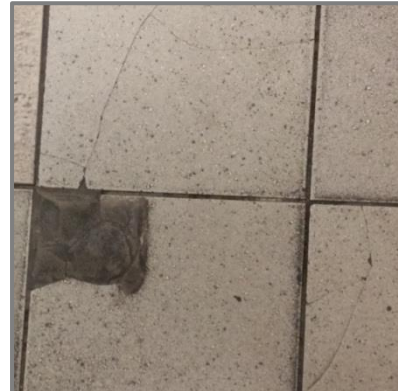
Tile replaced with filling material

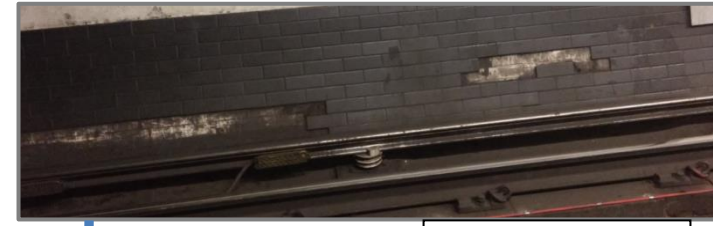
Tiles missing locally

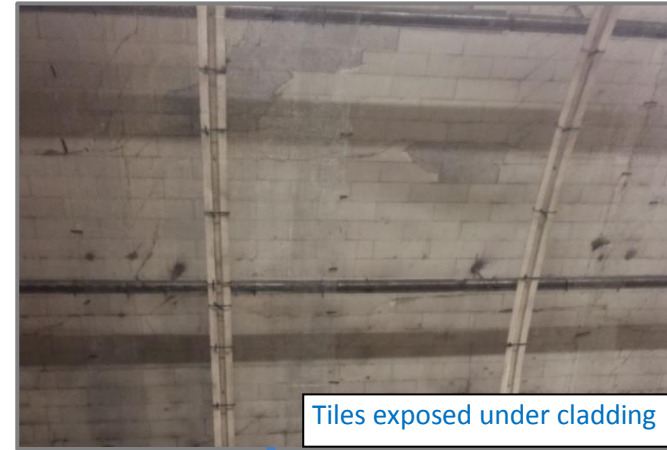
Tiles exposed under cladding

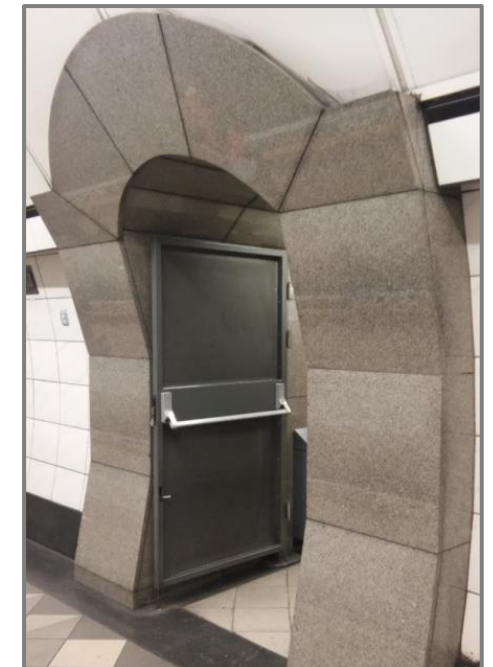
Opening cladding, sealed with flexible mastic – All cross passages

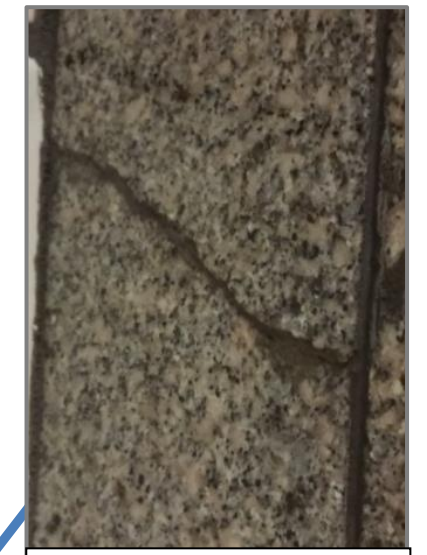
Tiles cracked in the vertical wall of the opening

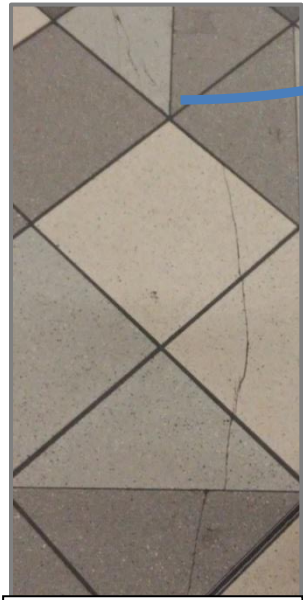
Cracked floor tiles

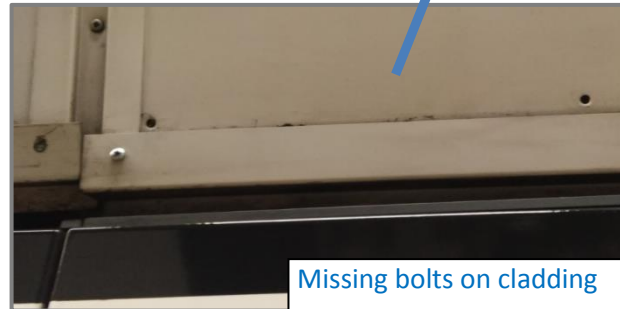
Missing bolts on cladding

During inspection it was observed that some bolts of the cladding were unscrewed/loosened or missing at places.
It is recommended that cladding is securely fixed during construction to avoid potential risk of tiles/finished falling.

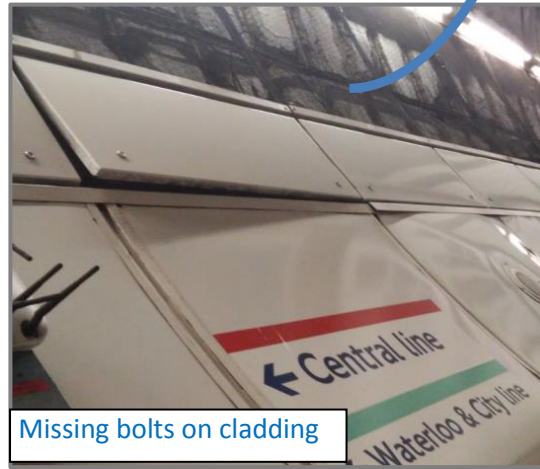
Missing bolts on cladding

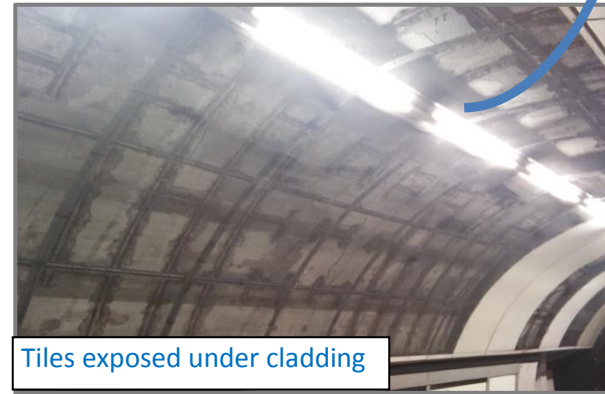
Tiles exposed under cladding

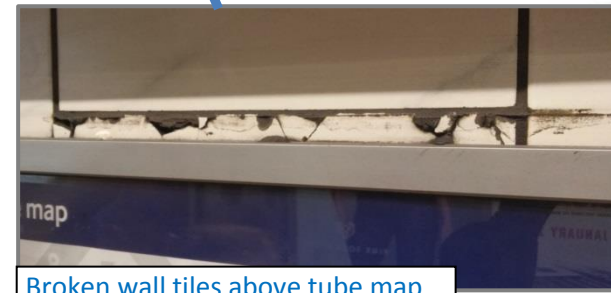
Broken wall tiles above tube map

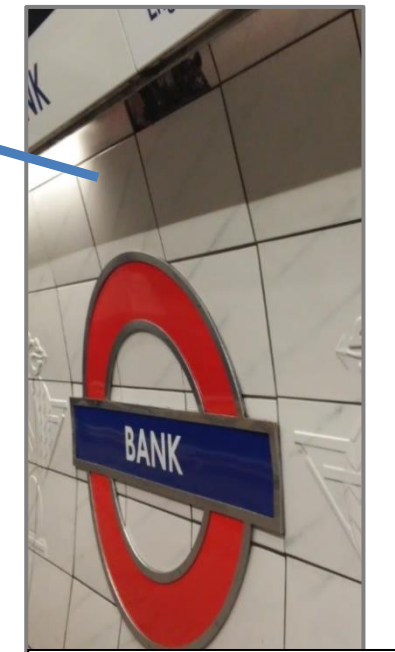
Broken tile removed under sign
