# Tunneling

# The detail in the DEVIL'S SLIDE

Located on one of the world's most beautiful coastlines, the twin tube Devil's Slide Tunnel is California's first NATM highway tunnel. Dan Zerga, of NATM tunnel designer ILF Consultants, and Sebastian Kumpfmüller, of CM partner Dr Sauer Corp, discuss experiences gained during the design and construction management of the project

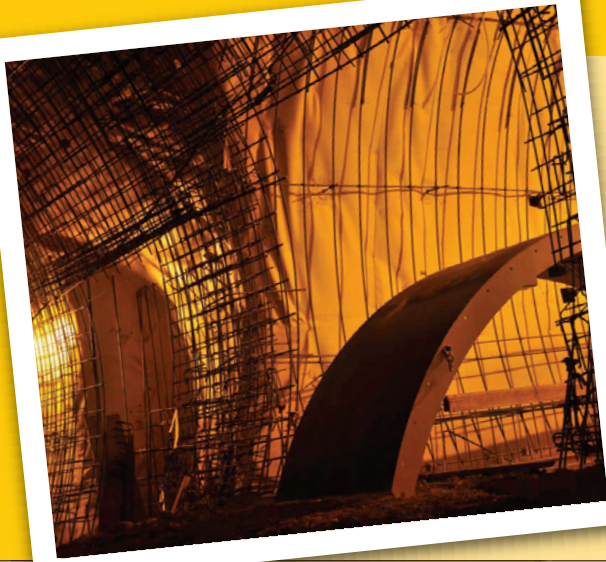
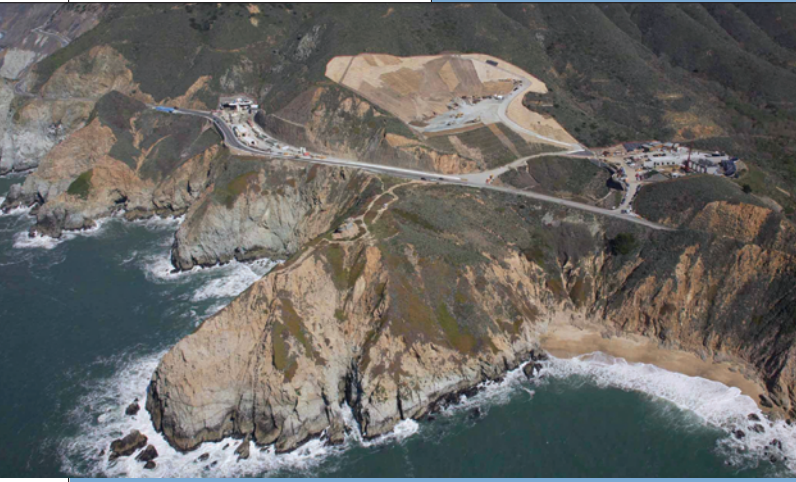
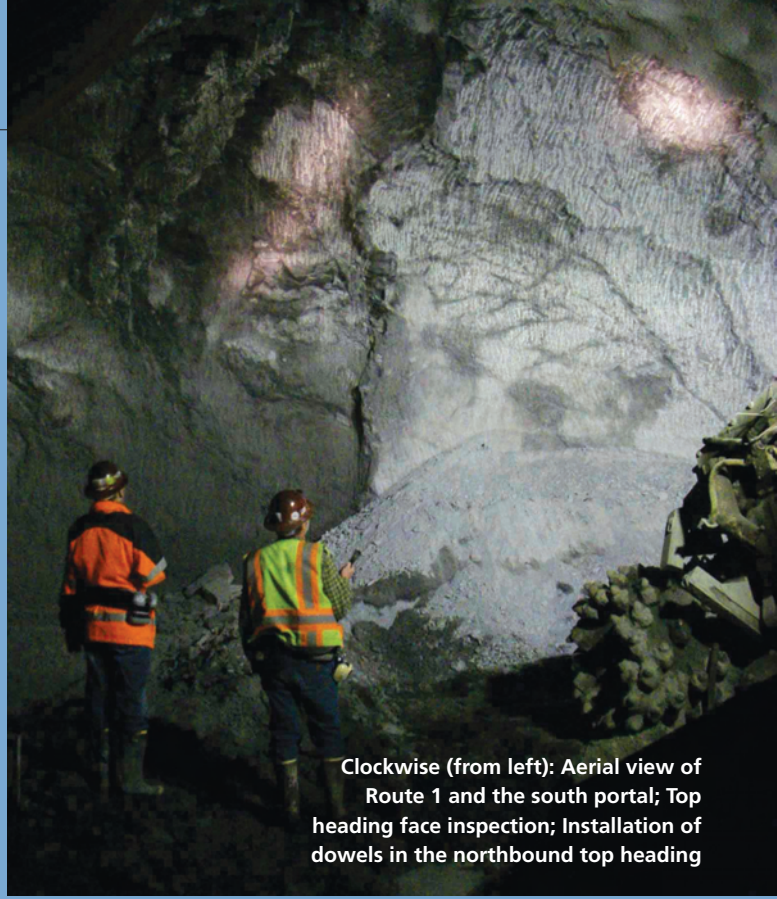
Clockwise (from left): Aerial view of Route 1 and the south portal; Top heading face inspection; Installation of dowels in the northbound top heading

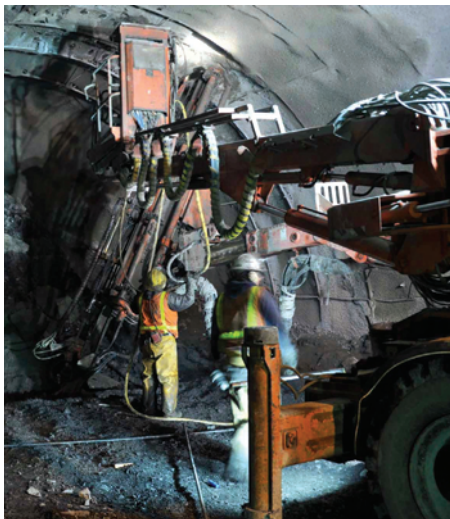
**Installation of dowels in the northbound top heading**
