PUSHING BACK

Seven deformed flood control tunnels that pass through a rail embankment were enlarged using a one-of-a-kind expander that pushed the deformed liner plates back into position with minimal disruption to rail traffic. **By Brian Fortner**

Cameron Run Tunnels

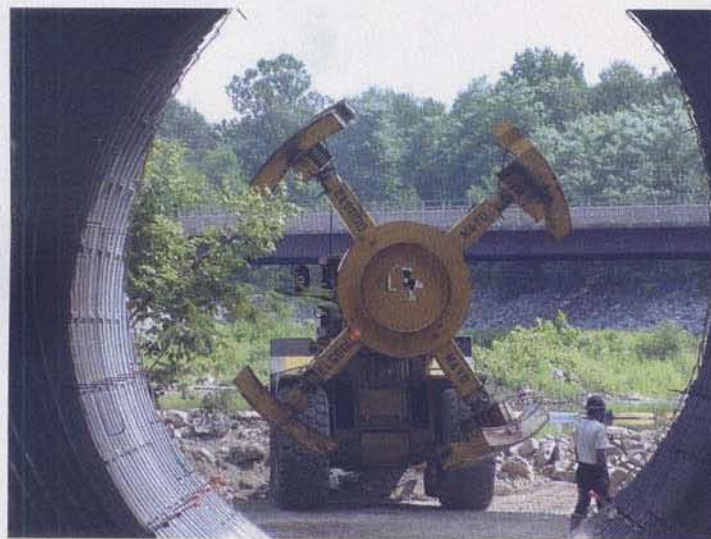
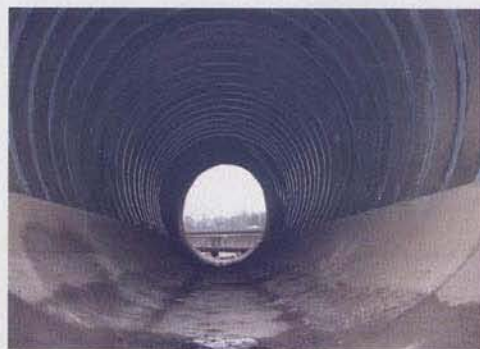
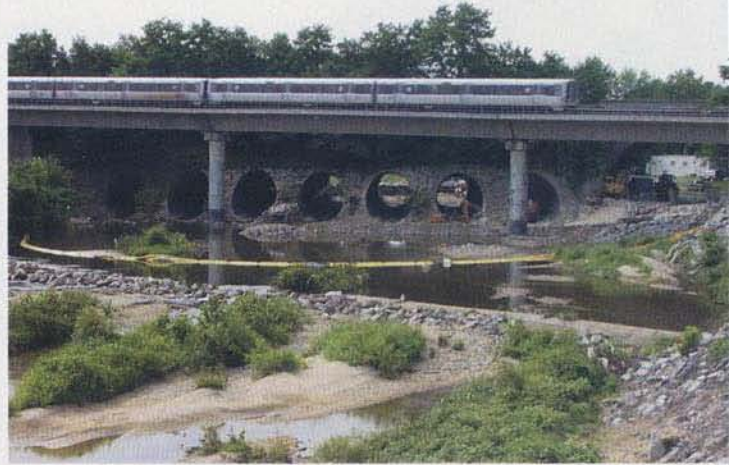
Construction crews had to build a cofferdam around transit piers near the downstream opening of the tunnels, opposite top. The expanding device, opposite below left, was driven into the tunnels. Shoes on each leg straddled the steel sets, and hydraulic jacks pushed them against the deformed liner plate. Timber pile bracing placed in 1994 kept the deformations—some as much as 1.25 ft (0.4 m) near the crown of the tunnels—from increasing, but they also reduced flow capacity and could be knocked loose by debris, opposite below right. The seven tunnels carry normal flows, but a concrete arch and a public bike path will help convey water from a 100-year flood, right.

The deformations typically occurred between the 9 and 11 o'clock positions and the 1 and 3 o'clock positions in the tunnels, so the expander was designed to be adjustable. The expander was attached to a steel set and placed against the invert of the tunnel, which had been reinforced. Crews then activated the 200 ton (183 Mg) hydraulic jacks on each leg to push against the deformed liner plate. Once the liner plate reached a predetermined position close to its original profile, the short filler piece was replaced with a longer, permanent steel piece that more accurately fit the new tunnel profile. The expander was then moved to the next steel set. Gall describes the process as an "expansion front that moved down the tunnels."

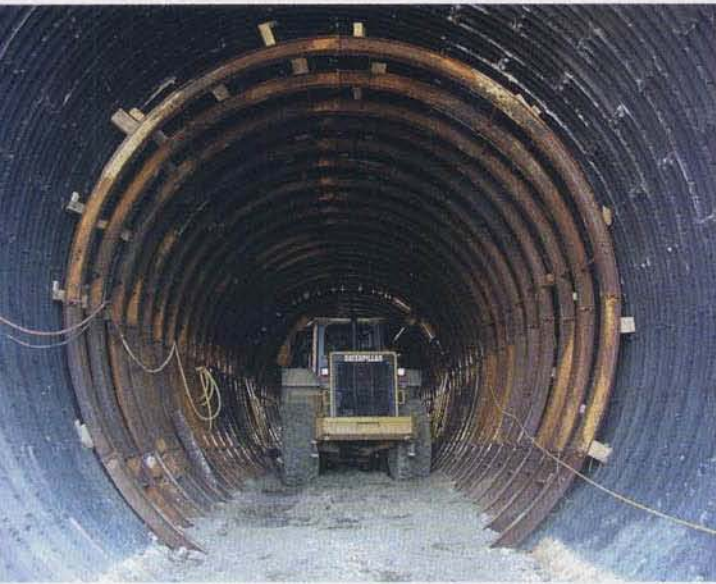
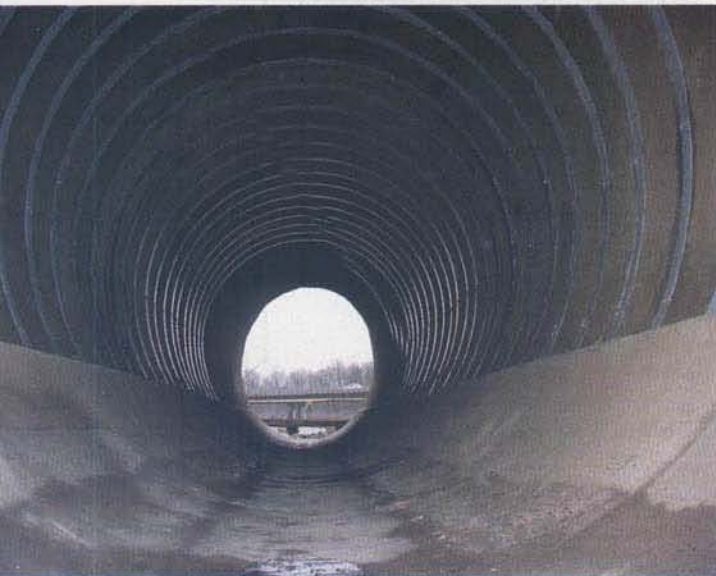
Once the liner plate was expanded, short filler pieces in the steel sets were replaced with longer sections to match the new tunnel profile. About 120 ft (37 m) in each tunnel was lined with steel sets spaced 3 ft (0.9 m) apart, top. The finished tunnel profile includes a concrete invert, above. The steel sets and shotcrete layers are 6.25 in. (160 mm) deep, which left the inner flange of the steel set exposed in the tunnels.

were expanded, the short filler pieces were replaced with longer sections to match the new tunnel profile. Each tunnel contains about 40 permanent steel sets over a distance of 120 ft (37 m). Temporary steel sets—three at each end of the expansion area—were installed for support.

Once the tunnels were lined with steel sets and expanded, structural shotcrete reinforced with steel fibers was applied for additional support. A final shotcrete layer without fibers provided the smooth surface that would augment hydraulic capacity. The structural shotcrete is 5.25 in. (13 mm) thick and the finish layer is 1 in. (25 mm).
